Vizcaya

Vizcaya
Lanais, Balconies &
Porches
Survey 2021 - 2022

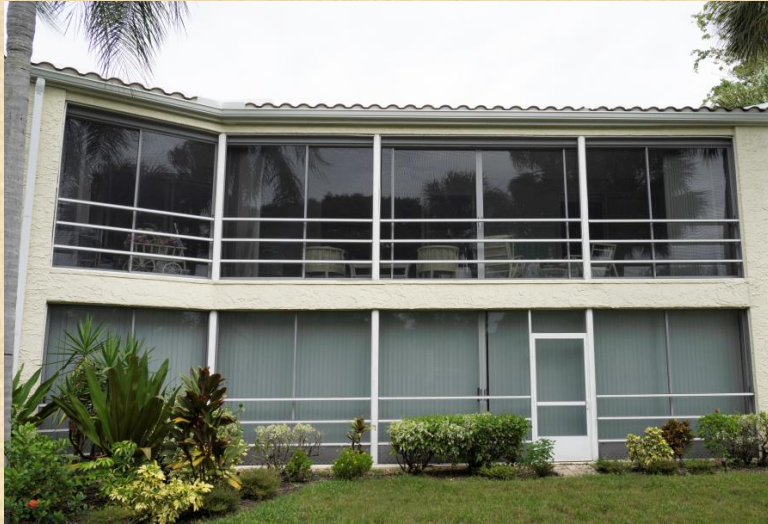
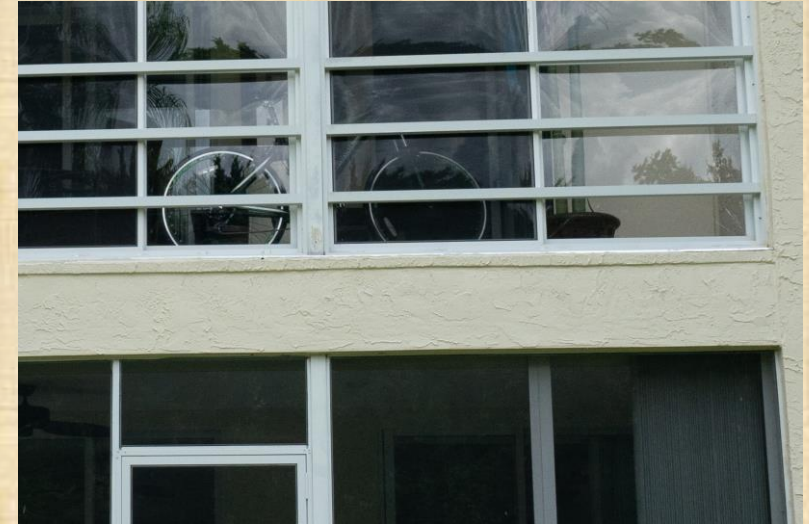
Original railings with no added flashing - (41 of this type)

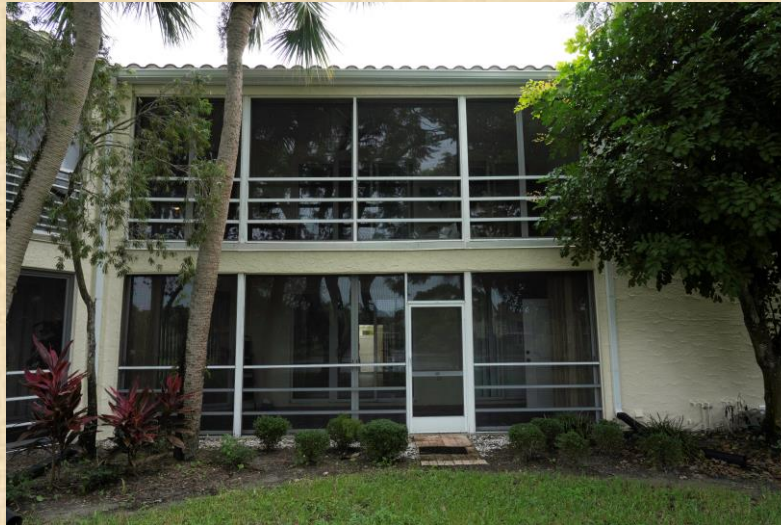
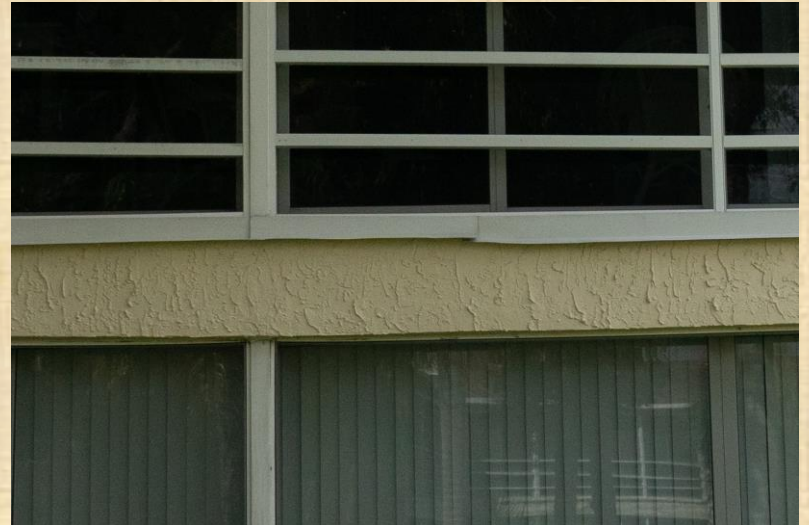
Original railings with added metal flashing (13 of this type)

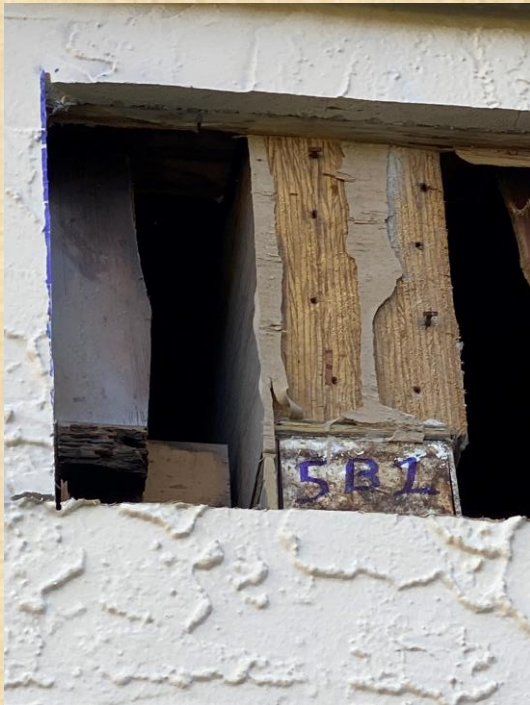
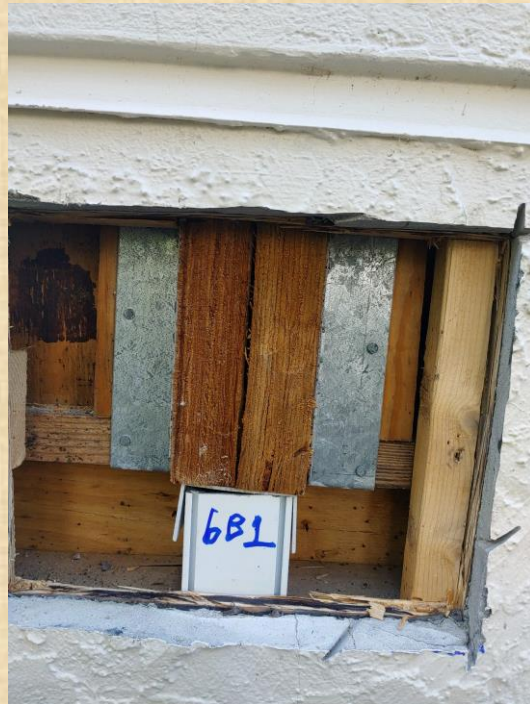
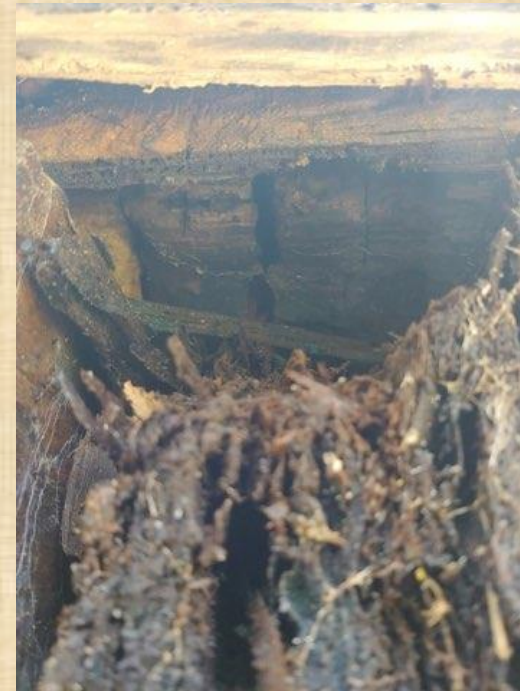
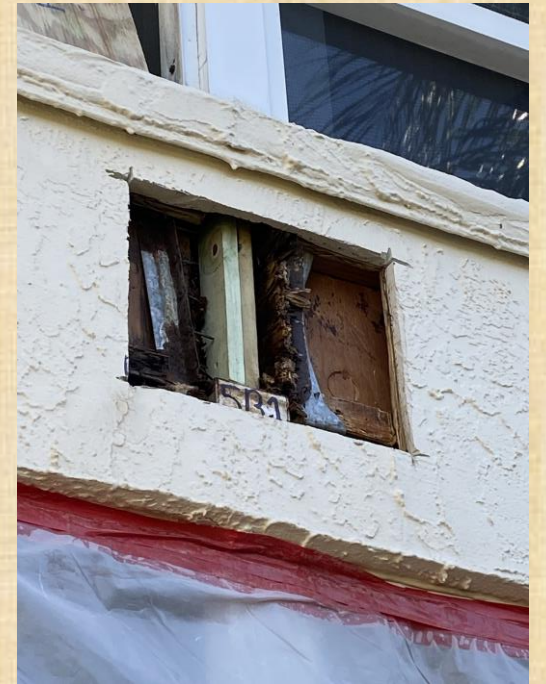
Examples of #1 Rating

Examples of #10 Rating

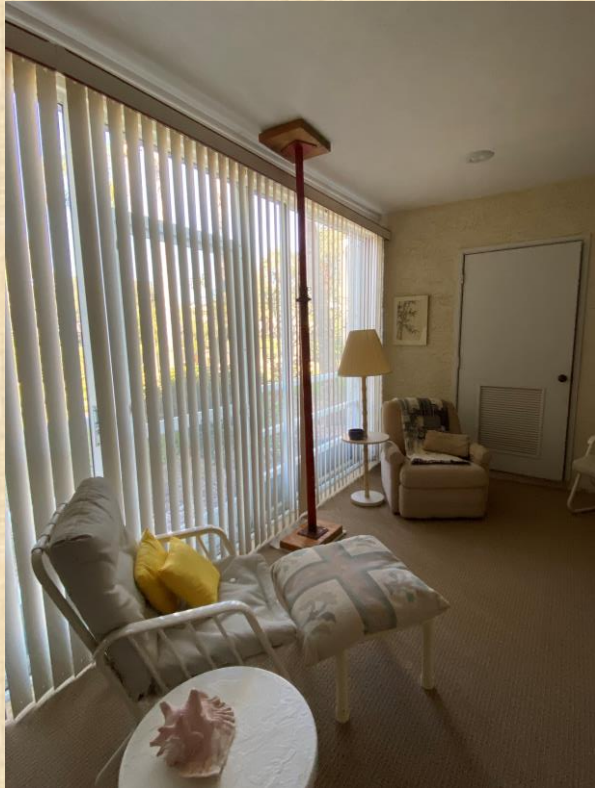
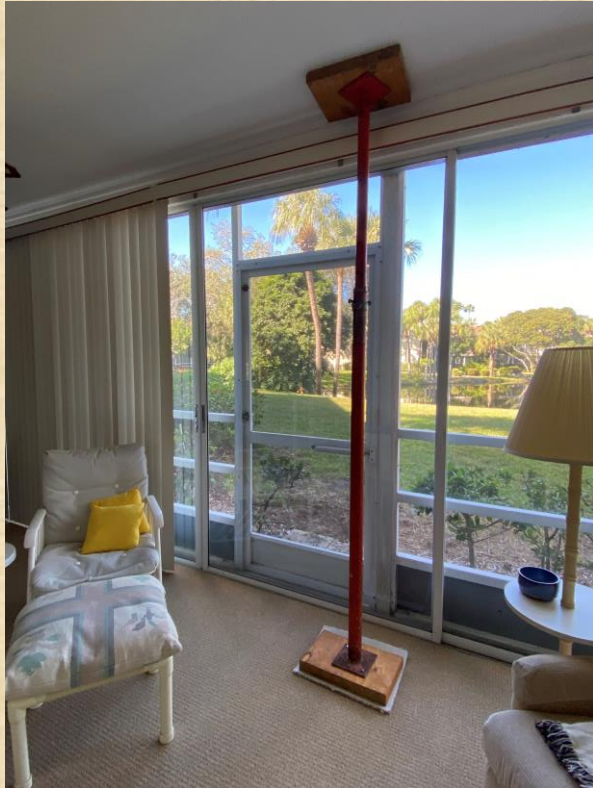
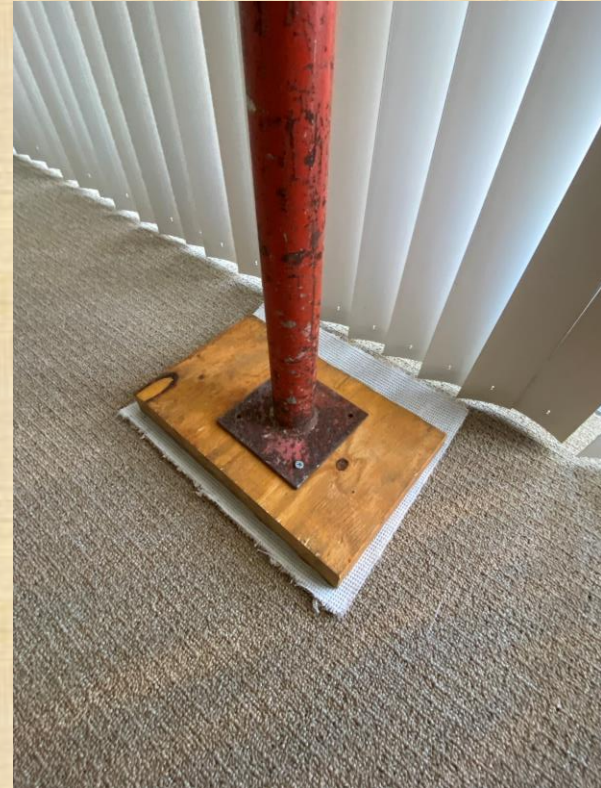
Temporary Supports Installed

- Example of temporary supports

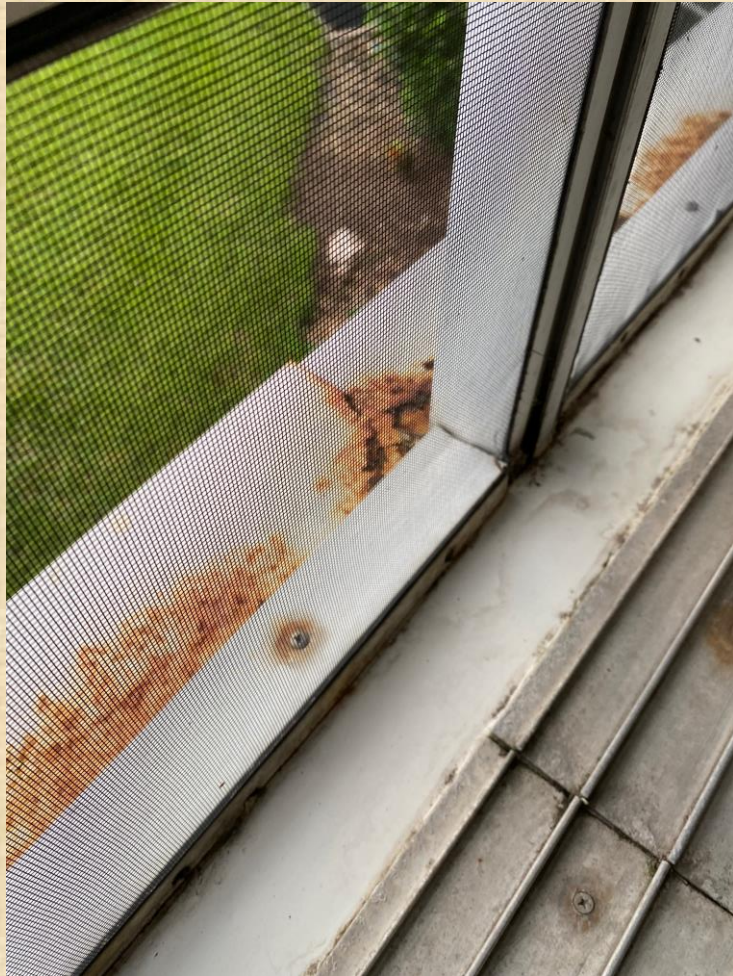
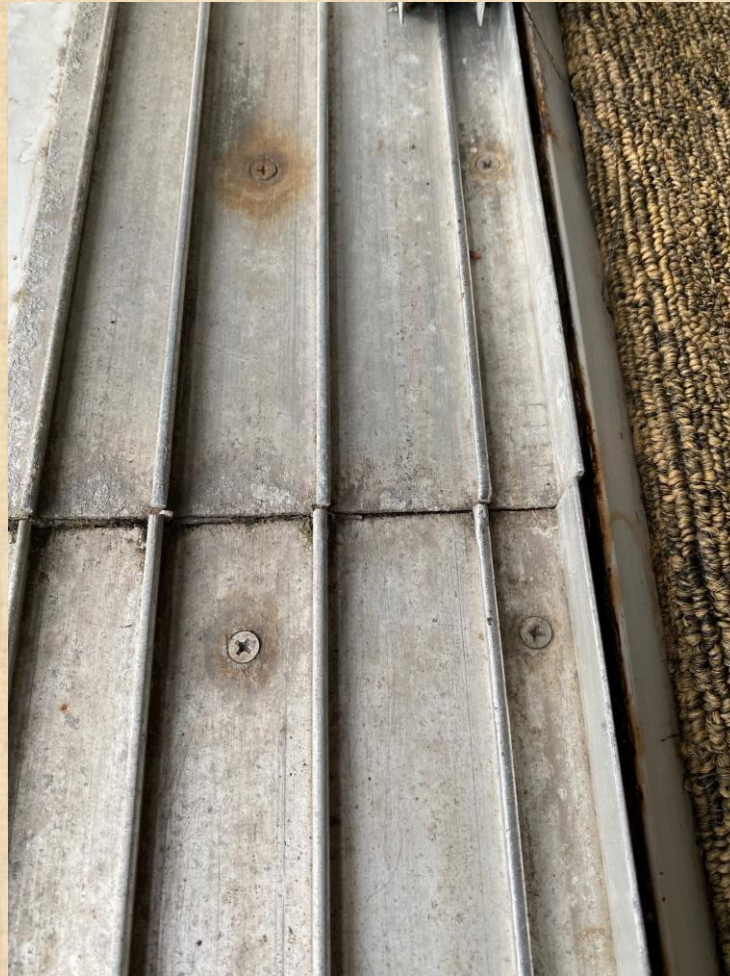
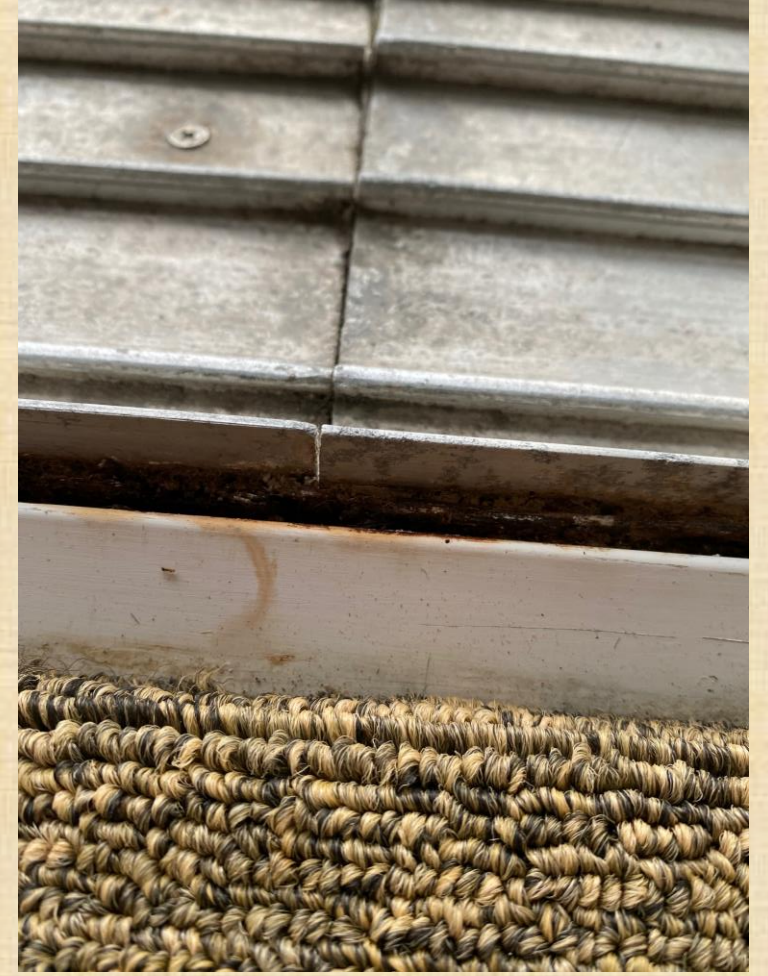
- Examples of metal flashing showing rust or leaks

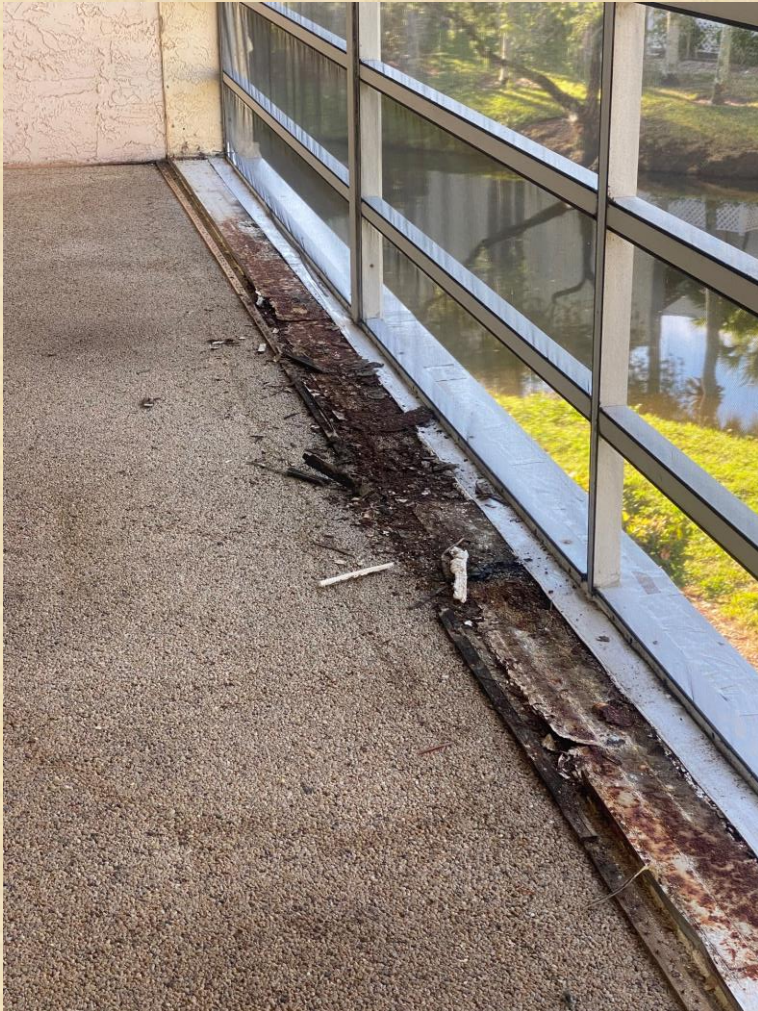
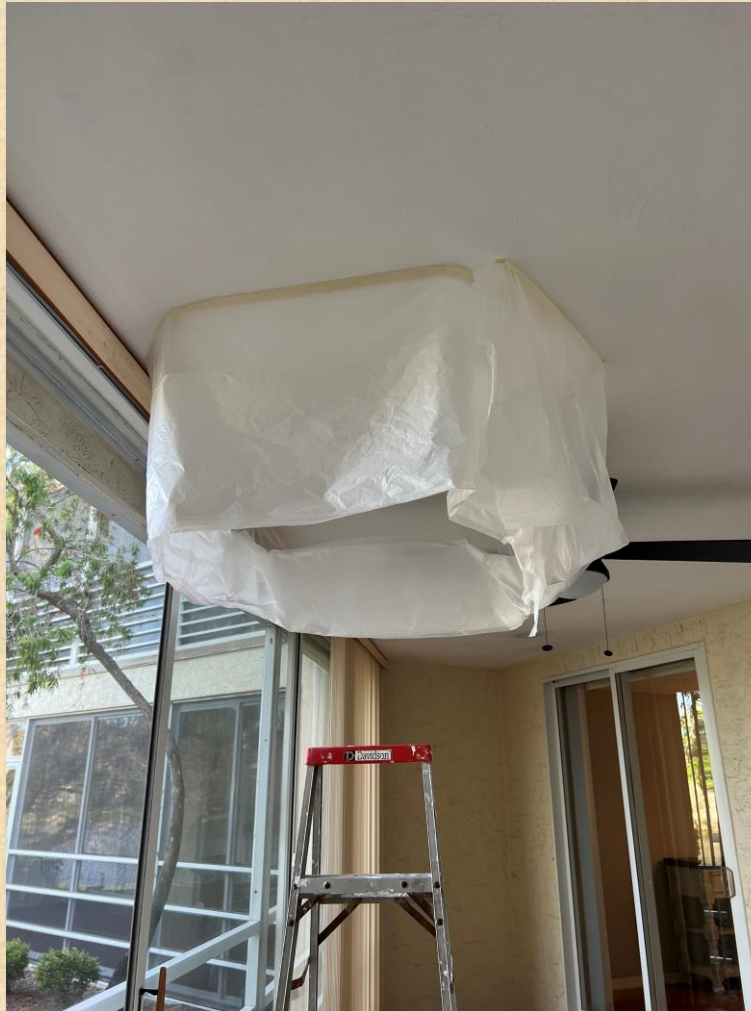
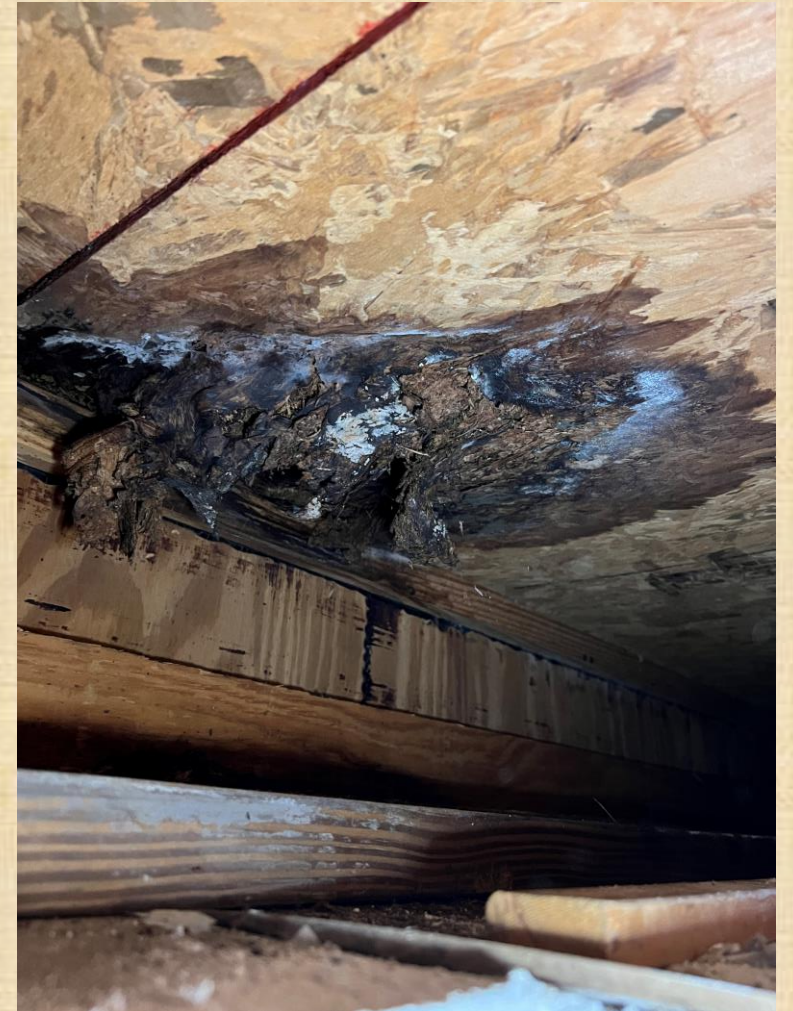
- Examples of metal flashing showing rust or leaks

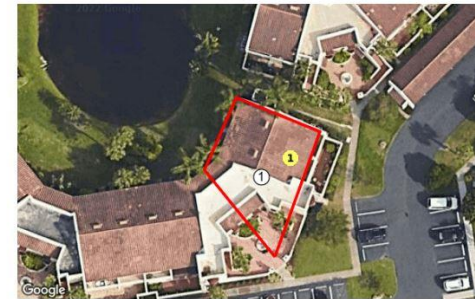
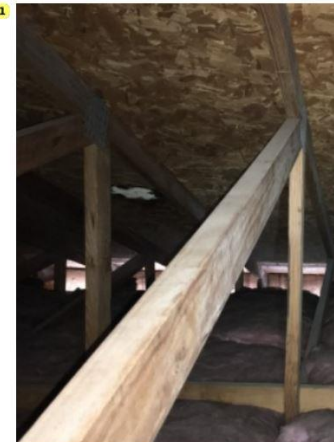
1 Tile Roof - Field Leak (Emergency)

Active field leak in roof system may cause additional damaged to structure.

Remove existing tiles and set aside at leak location.

Remove all roofing material down to decking. Replace any rotten wood as needed. Addtl. woodwork will be billed accordingly.

Install a two ply self-adhered membrane system in areas being repaired.

Re-install tiles using foam adhesive, caulk, and tile mortar.
