Vizcaya

Vizcaya
Lanais, Balconies &
Porches
Survey 2021 - 2022

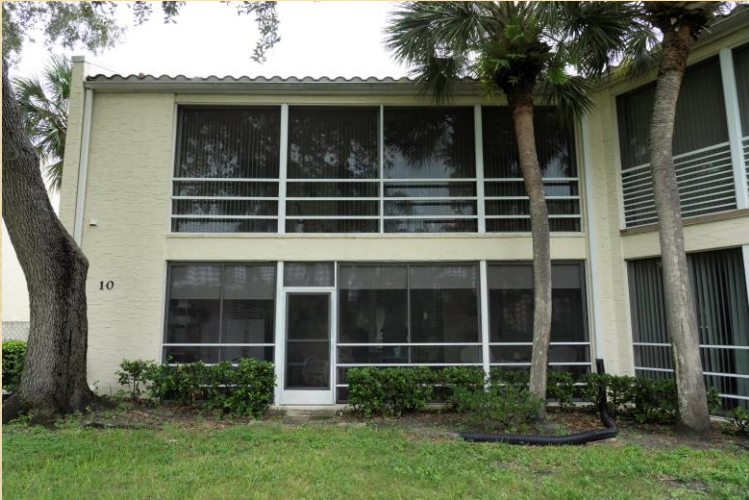
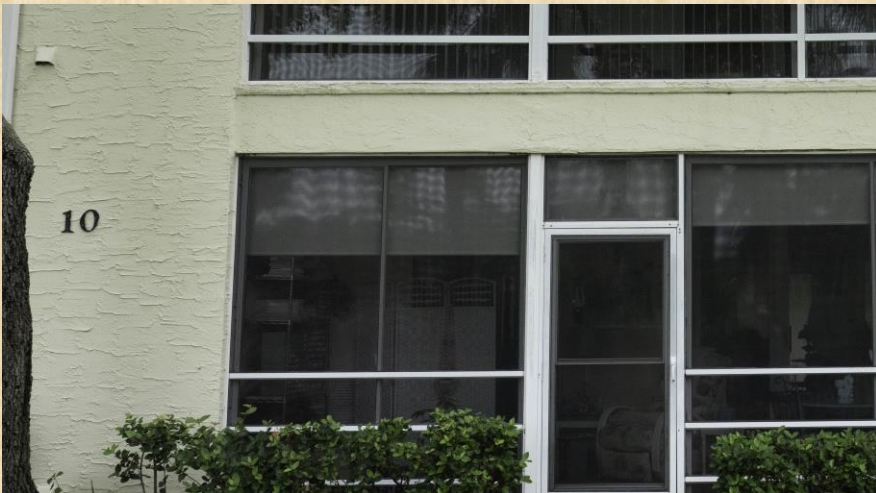
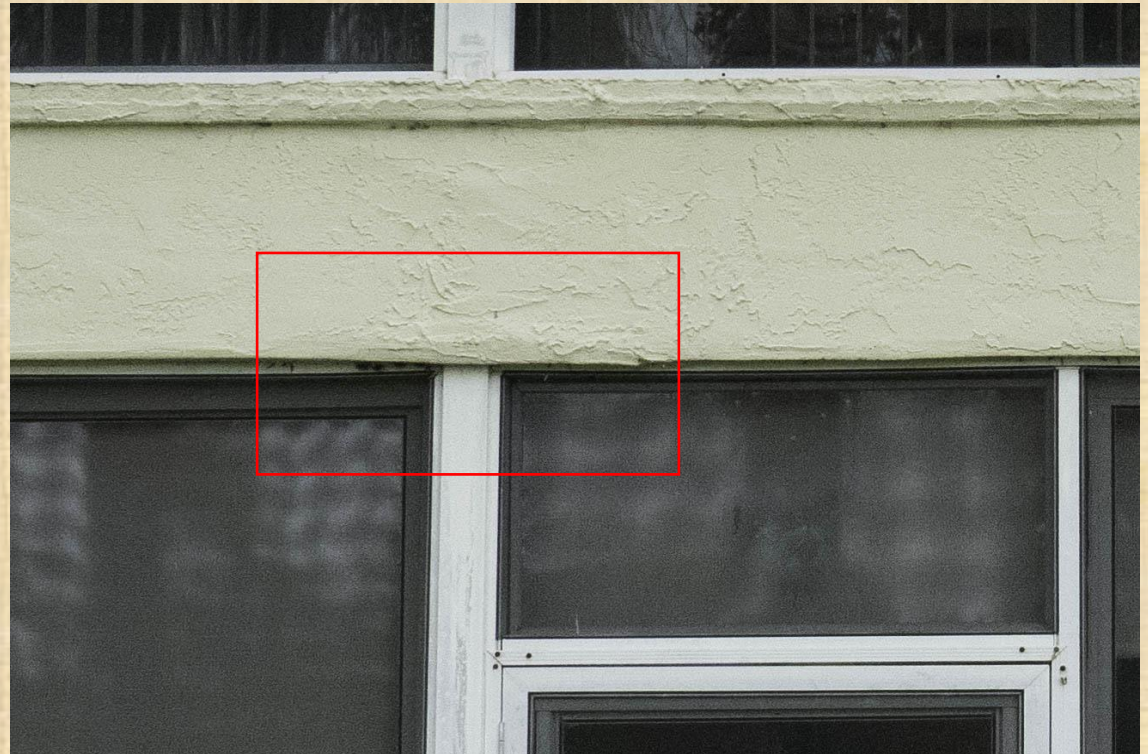
Batch #1 – Inspections

Units selected based on non-destructive visible sagging with original 3 railings

Batch 1 inspections completed September 2021
10FH, 19BD, 20AC, 15FH, 24AC, 24EG, 21FH, 3FH,
18AC, 26EG, 27BD, 27FG, 26BD,(1BD)

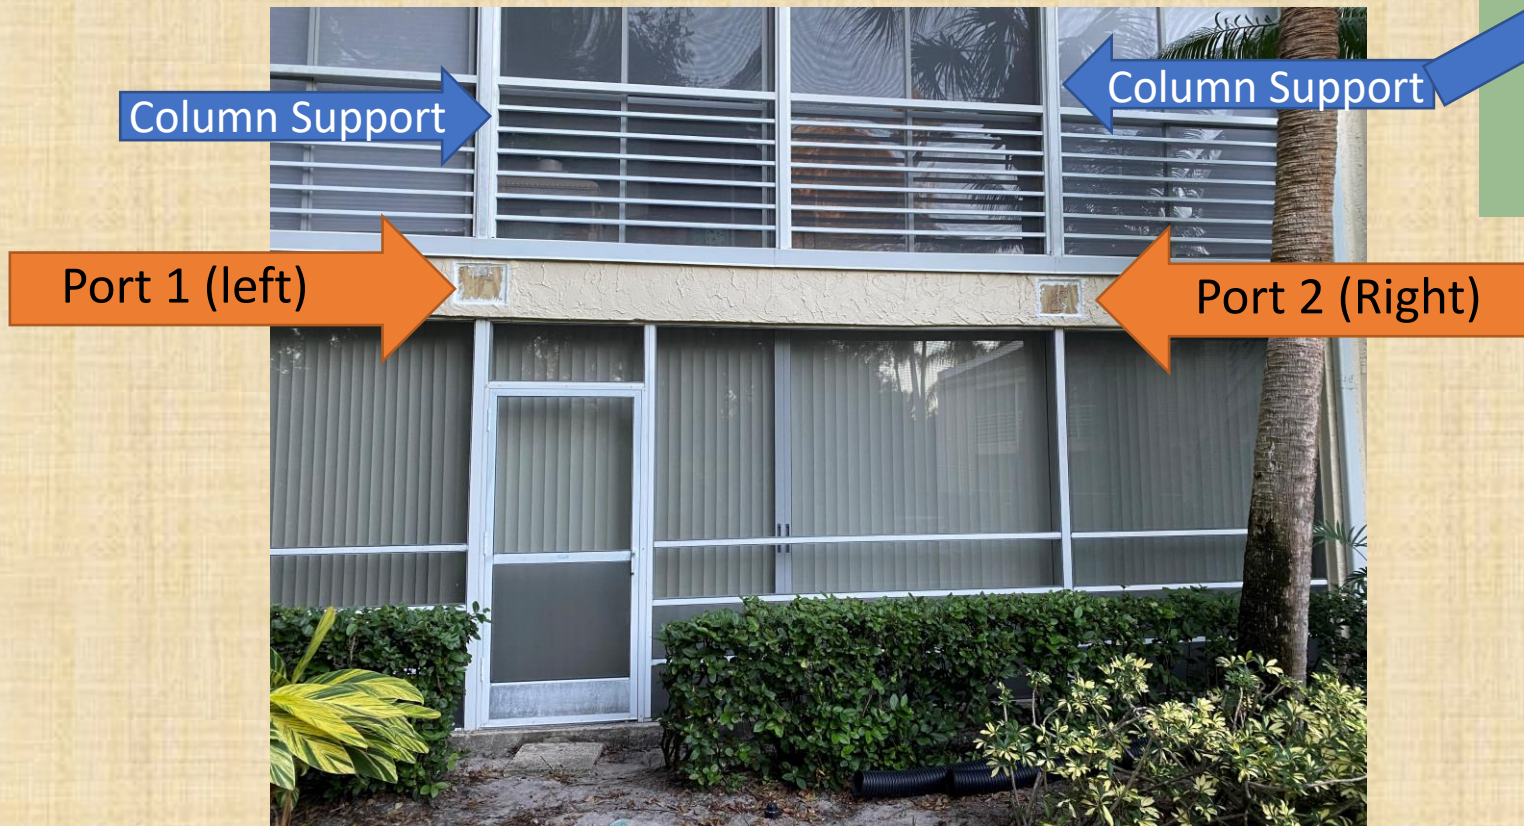
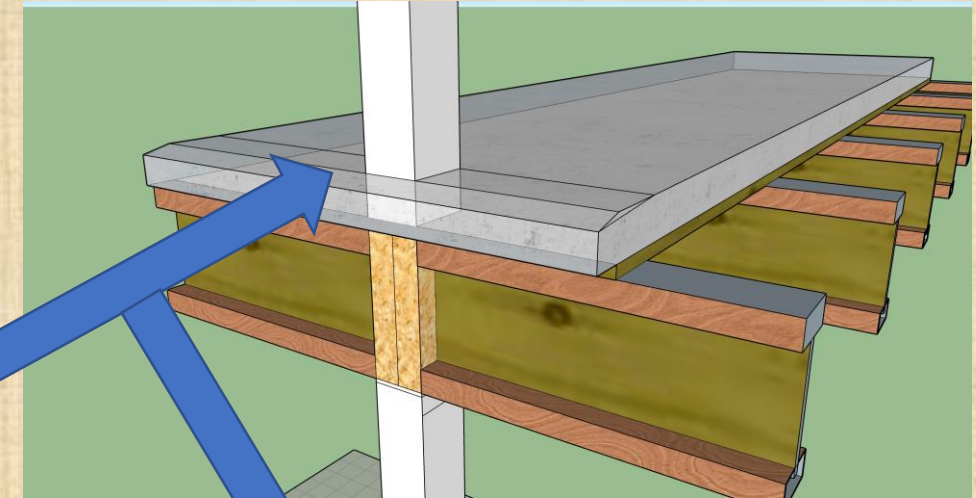
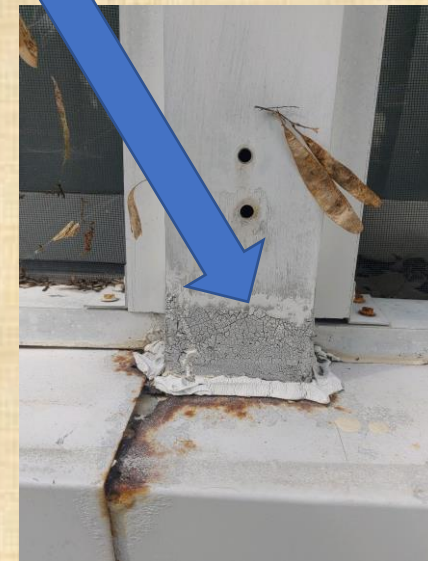
Cutting Inspection Ports at Beam Supports

- 2 inspection ports cut at 2 Small Lanais
- 3 inspection ports cut at 3 Larger Lanais

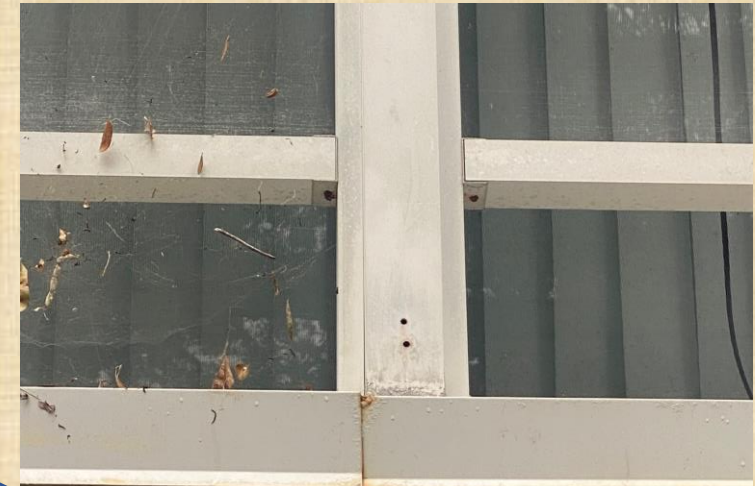
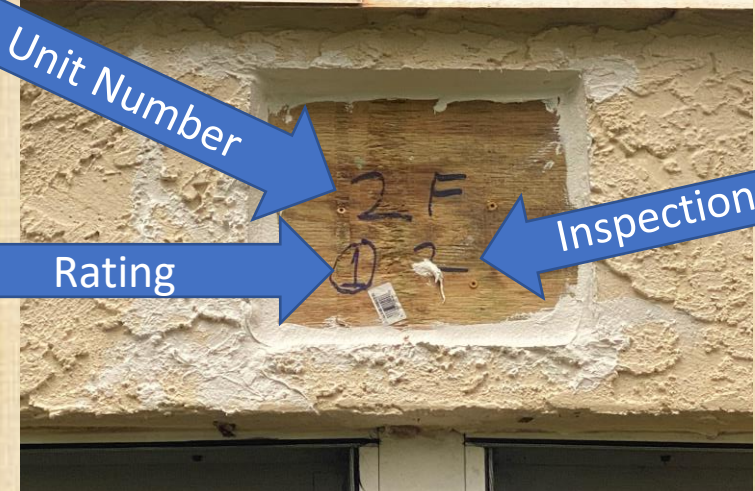
Deterioration Rating Scale - #1 thru #10

- 10 - Eminent failure - Rebuild immediately. Sagging visible - Provide Temporary support
- 9 - Serious rotting - Moisture present - sagging visible - Rebuild within 2 months
- 8 - Serious rotting - Moisture present - sagging visible - Rebuild within 6 months
- 7 - Serious rotting - Moisture present - sagging visible - Rebuild within 8 months
- 6 - Some rotting - Moisture present - no sagging visible - Rebuild withing 12 months
- 5 - No rotting - Moisture present - no sagging visible - Rebuild within 18 months (attampt to caulk leak
- 4 - No rotting - No moisture - original construction - Monitor and Rebuild within 36 Months
- 3 - Rebuilt at one time - no moisture - not done with Duradek - Monitor -
- 2 - Rebuilt at one time - Rebuilt with Duradek Flashing - Monitor
- 1 - No visible issues - Rebuilt wth Duradek Flashing - Not Opened

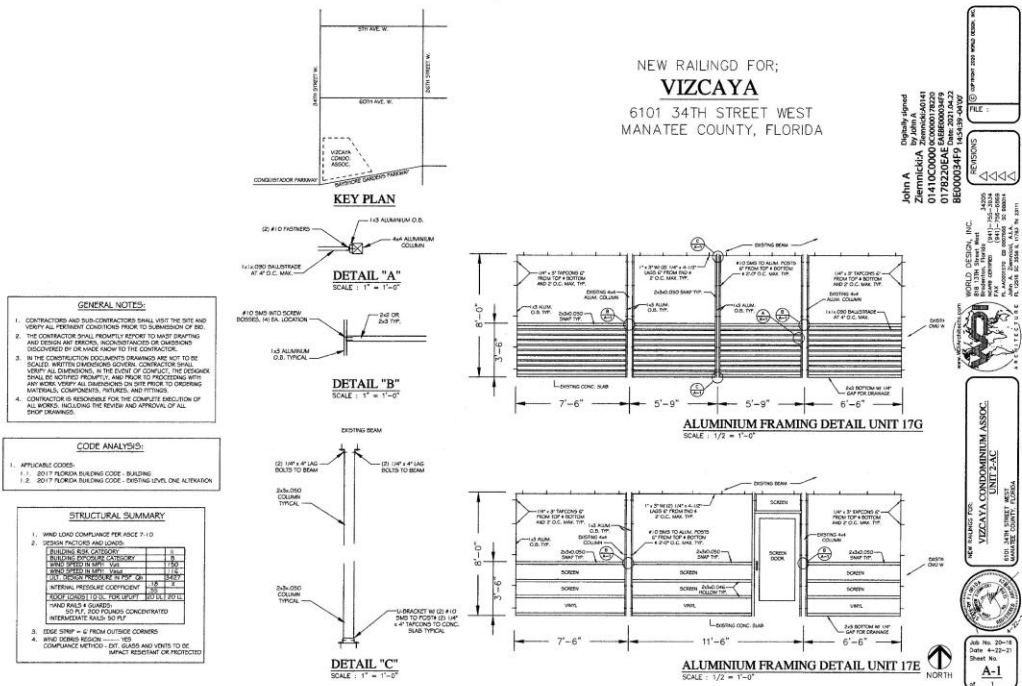
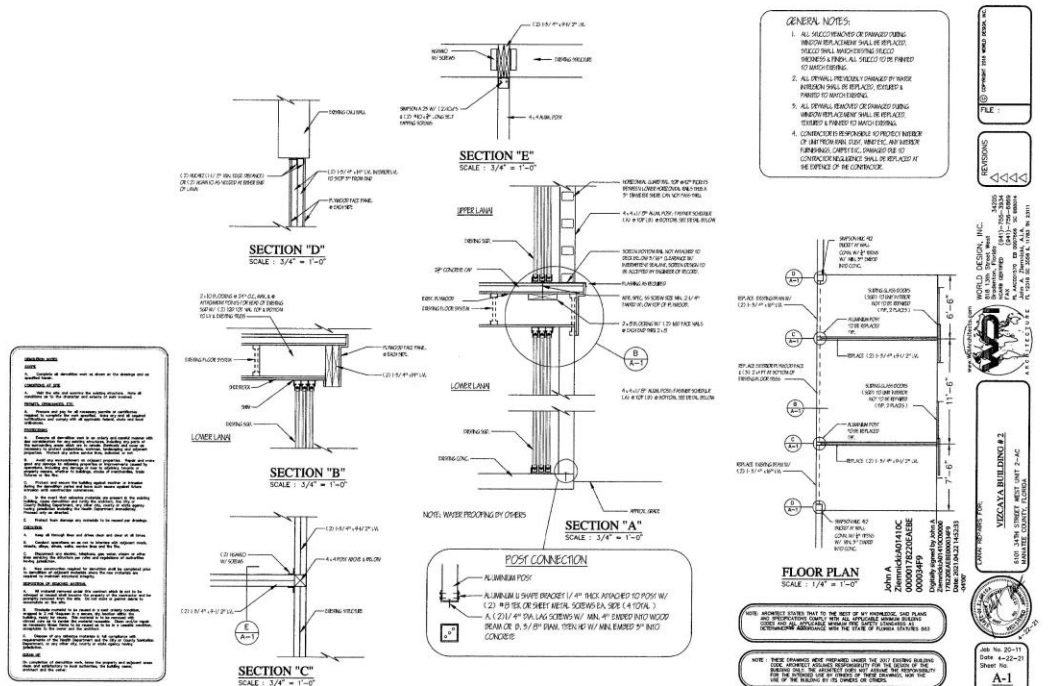
Permit Drawings for Units 10FH, 19BD, 24AC

These units are now completed
